Exhibit EN-HLD-5 Viewshed Analysis Map
Scenarios 2 and 3: Decommissioning and Dismantling

June 06, 2014

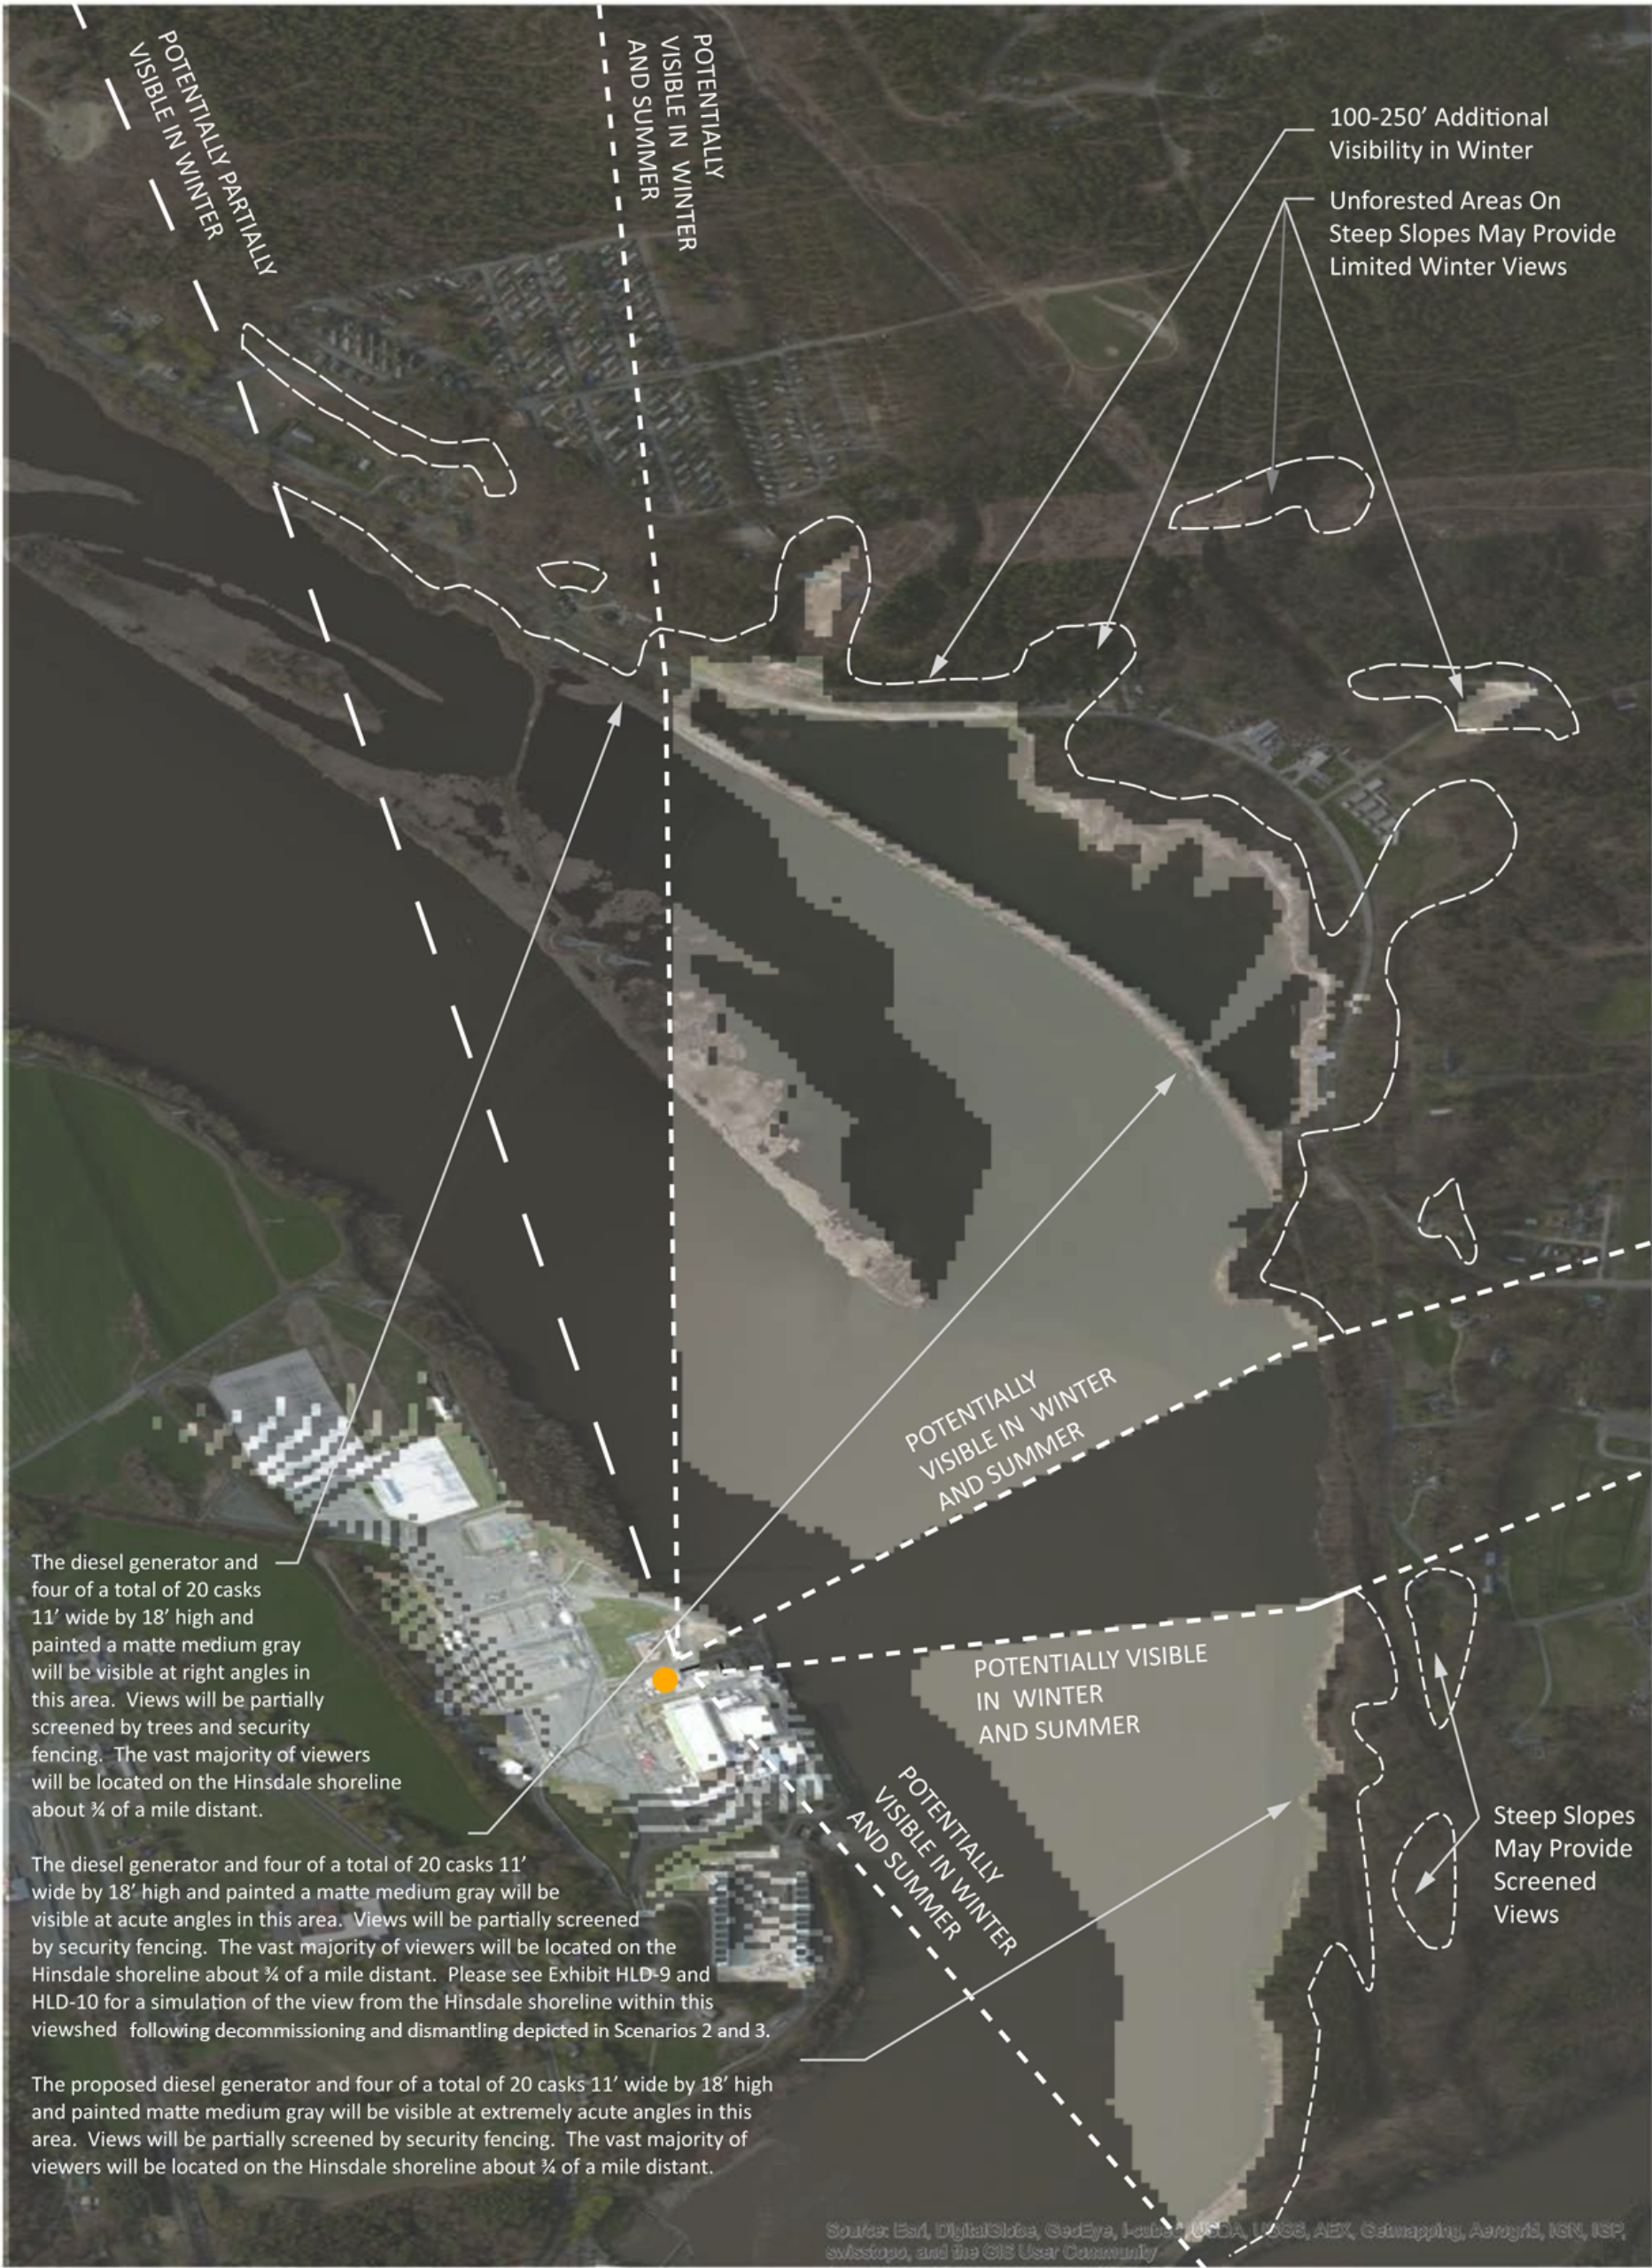
Visibility analysis performed by Dodson & Flinker, Inc. in ArcMap 10.2, using 10M Digital Elevation Model from the USGS (c. 2010) and forest/building obstructions digitized in ArcMap 10.2 from 0.3 meter resolution ESRI World Imagery (c. 04/09/2011).
