Vermont Yankee Nuclear Power Station

Radiological Historical Site Assessment

September, 2014

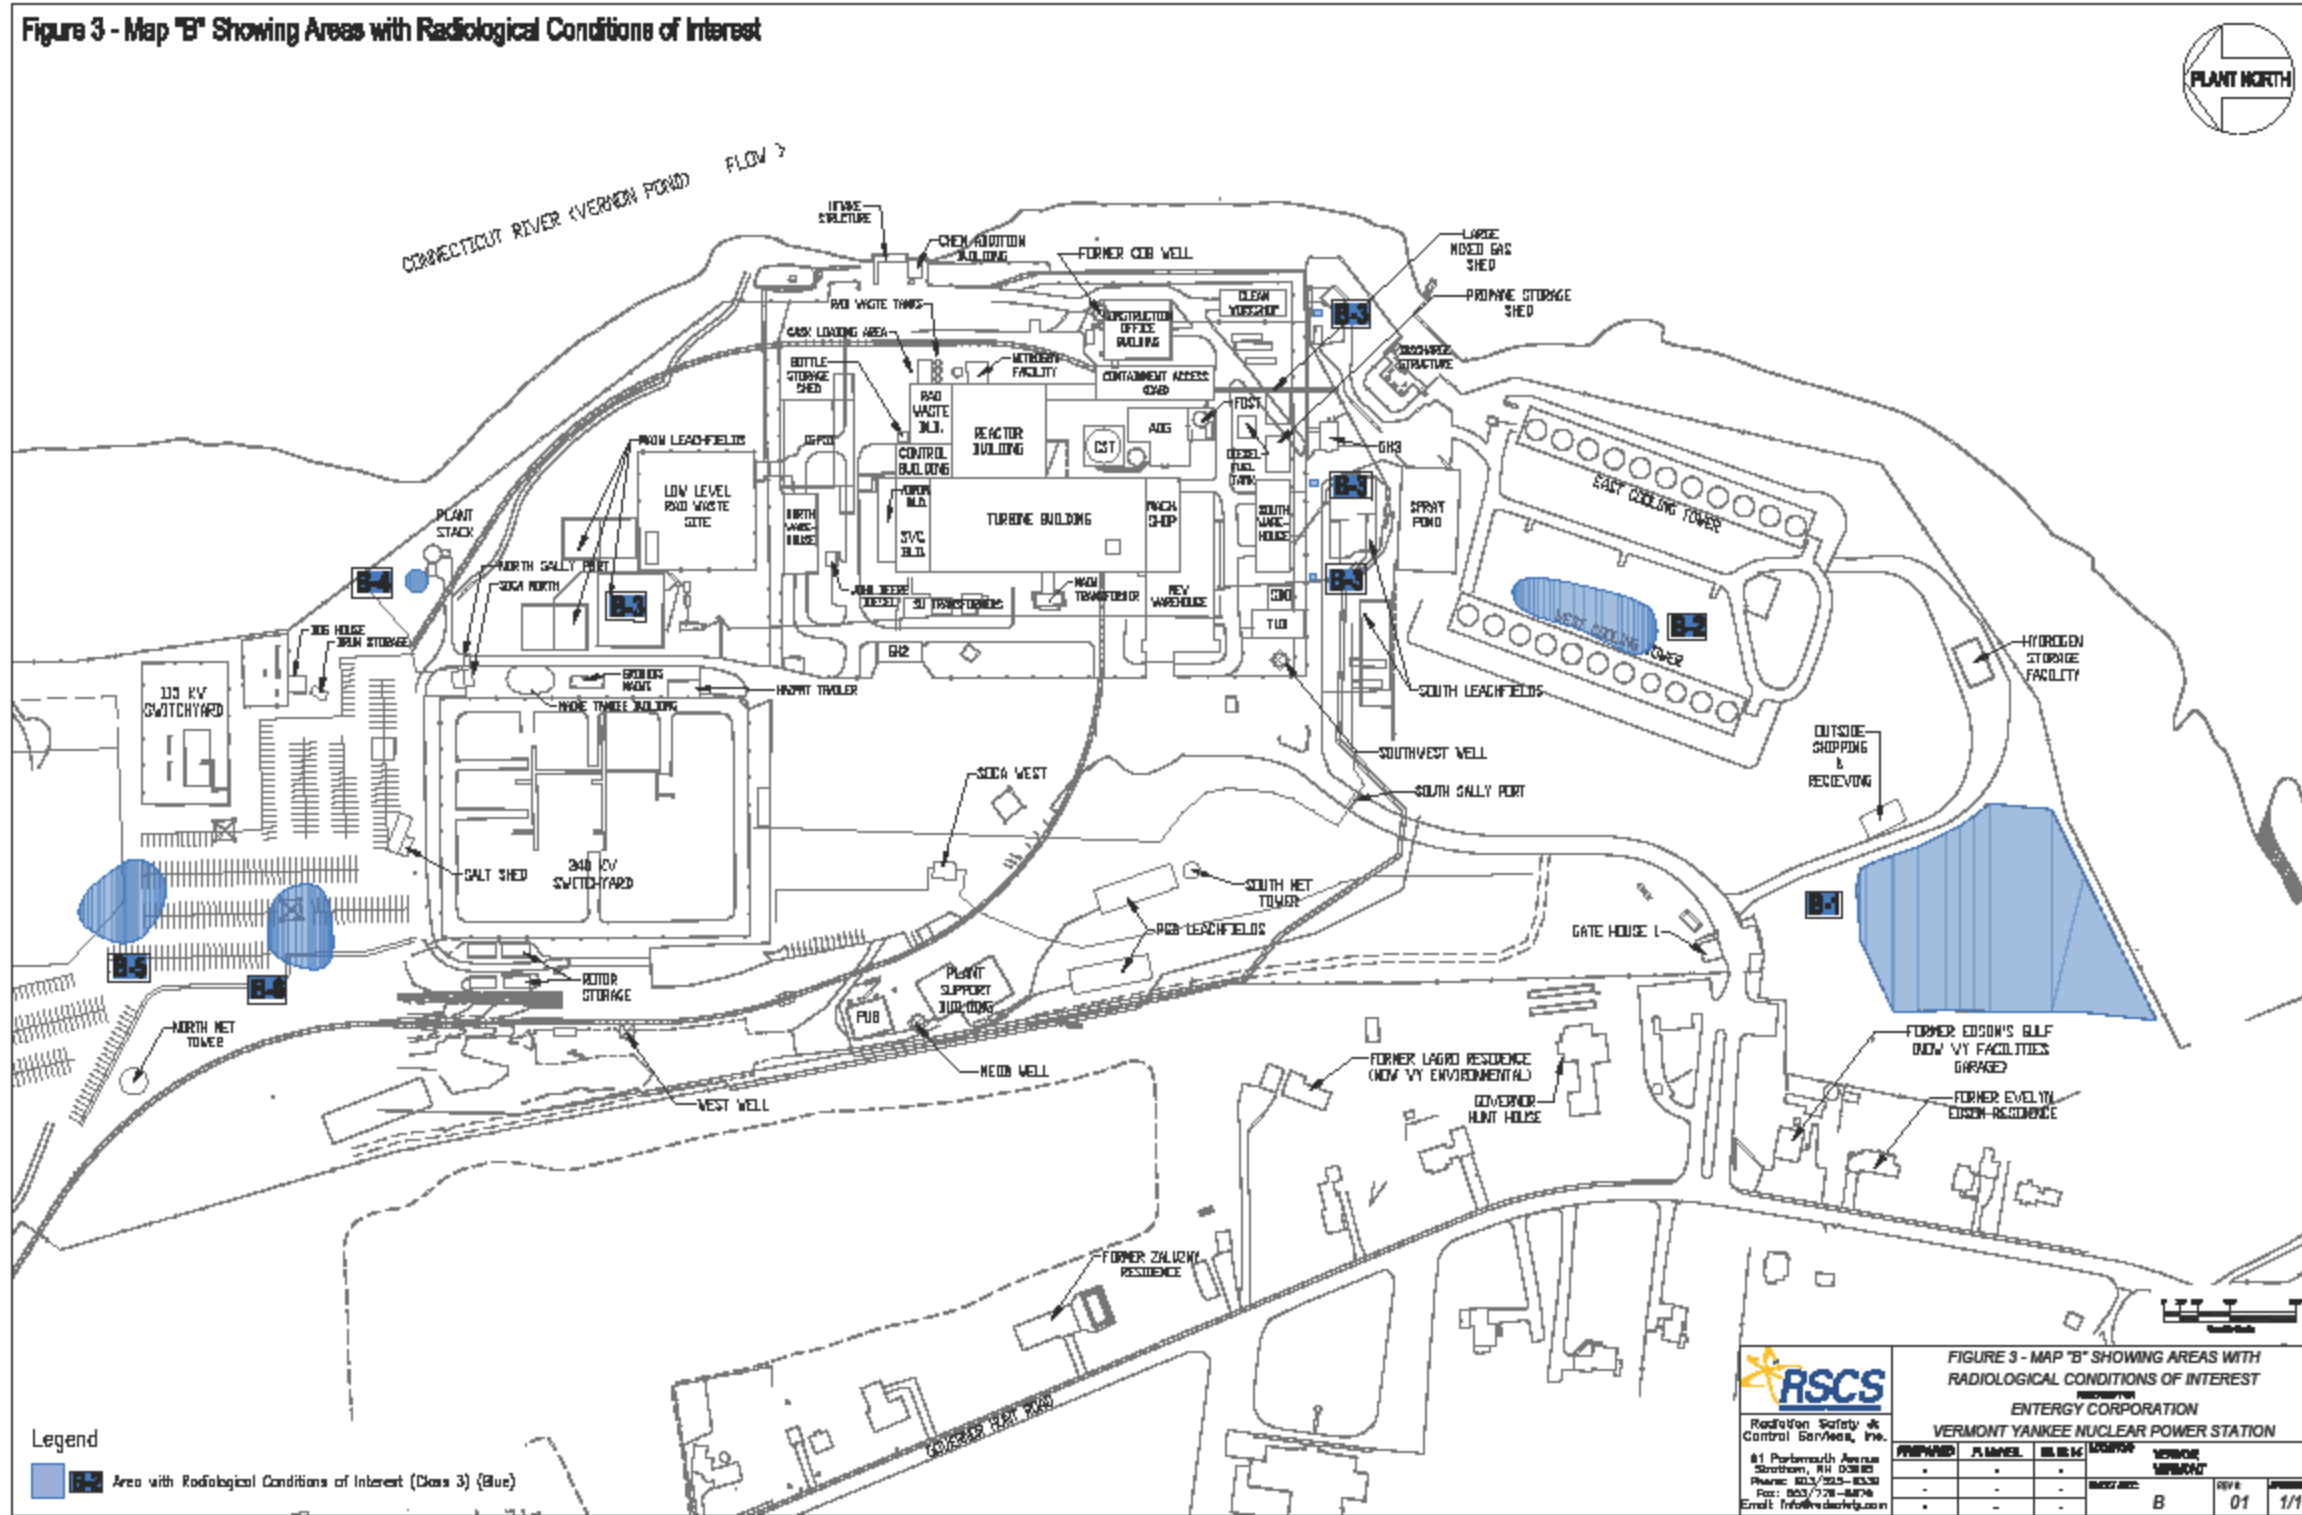
Figure 3 Map "B" Showing Areas of Radiological Conditions of Interest

No.	Area	Figure No. / Map Location	Current Condition	Prelim Class (1, 2 or 3)	Justification for Preliminary Classification
6	Septic Leach Fields and Tanks	3 / B-3	Groundwater from monitoring wells in each leach field and liquid effluent from septic tanks are sampled and analyzed for tritium and gamma-emitting radionuclides semiannually in accordance with the indirect discharge permit. No radioactivity above background has been detected in the effluent or groundwater samples. The leach fields and septic tanks will be evaluated for potential contamination at the time of decommissioning. This is a recognized NRC Bulletin 80-10 issue (contamination of a nonradioactive system). The septic systems will continue to be operated according to plant procedures through the decommissioning process.	3	Low potential for residual contamination exists.
Underground Pipes					
7	Underground pipe chase (trench) located between AOG Building and Turbine Building	1 / B5	Tritium was detected in a groundwater sample collected in November 2009. An investigation was initiated to determine the source of the tritium. A leak was determined to be coming from pipes within an underground pipe chase (pipe trench) located between the Turbine Building and the AOG Building. The area of the leak was excavated and the leak was stopped. The two drain lines that were leaking were isolated and new accessible lines were installed during refueling outage RFO-28. A groundwater extraction well was installed and pumped for several months to remove tritium from the aquifer. Natural attenuation of the tritium is continuing as of July 2014 and concentrations in groundwater continue to decrease. As of July 2014, no groundwater samples contain tritium at concentrations greater than the drinking water standard of 20,000 pCi/l. No tritium above background has been detected in the river. A dose assessment for tritium has been performed and it has	1	Potential residual contamination in inaccessible areas.
